EIFS Moisture Intrusion Inspection Report

Prepared for: John Homebuyer
Property Location: 125 Waterfront Way.
The Shore, NJ 00000
Date: June 2005

Peter G. Engle, PE

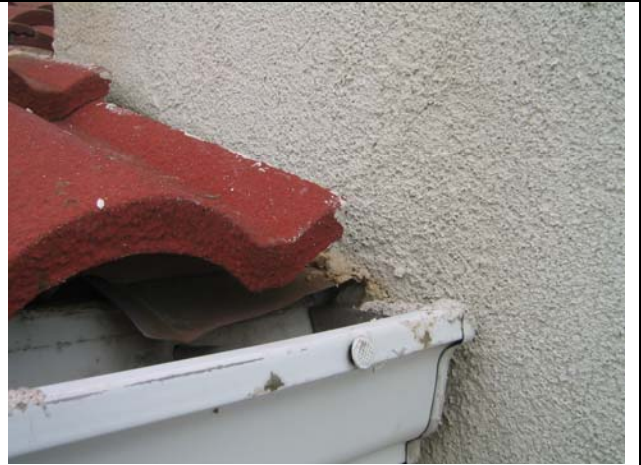
Photo 8. Missing Kickout Flashing

The only roof detail that is missing is the required kickout flashing at the gutter ends where the lower eave edge of the roof intersects with a sidewall. Photo 8 shows this missing detail at the back chimney. Missing kickout flashings are the cause of most of the damage associated with EIFS leakage.

With the scanner and probe, we found readings at or above 30% in a number of areas, and there is water damage in most of them. There is serious leakage from the missing kickout flashings on the back chimney and possibly from the chimney cap. There is also substantial leakage on the right side of the house from either the upstairs windows or the chimney. There is damage across broad areas of the right side of the house and the back chimney. There is also damage on the left side of the house, but more localized around the windows.

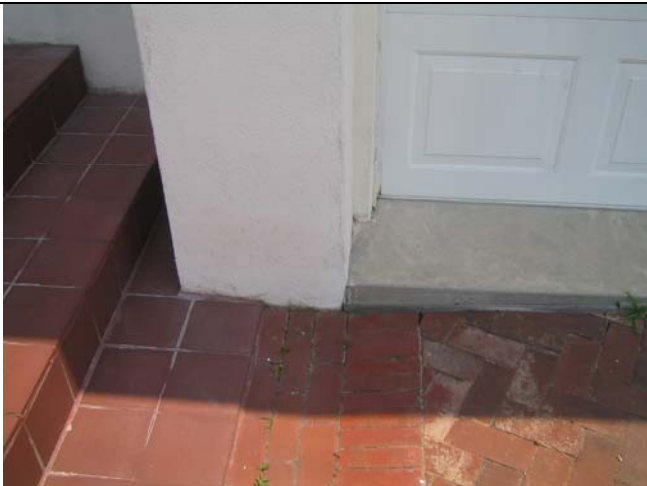
Photo 15. EIFS Below Grade

11. Lower Edge Termination & Grading: EIFS should always be terminated above grade. Terminating it below grade can allow moisture to wick up behind the system. It also creates conditions conducive to termite and carpenter ant infestations, and these can be difficult to locate due to the shelter provided by the EIFS.

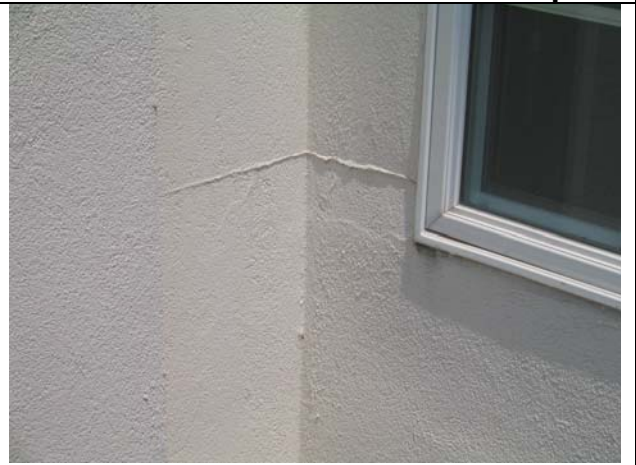
Photo 16. Stress Cracks

13. Control (Expansion) Joints: Expansion joints are required at each floor level to accommodate house shrinkage and settlement, and seasonal expansion. This house has no expansion joints between the first and second floors or at the foundation line. There are stress cracks and wrinkles in the system that are typically caused by this lack of expansion joints.

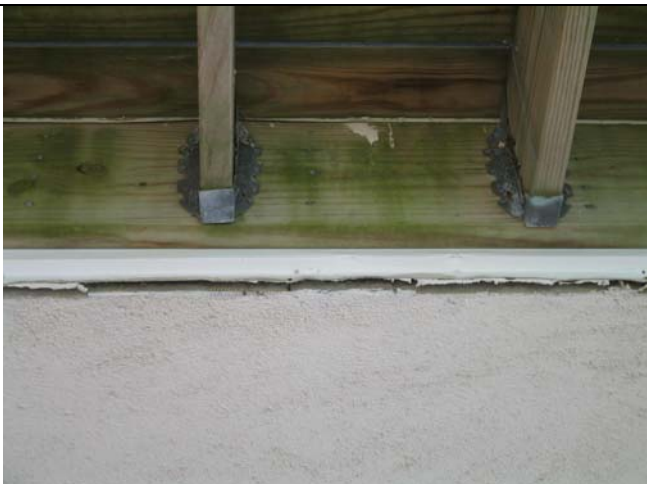
Photo 17. Deck Flashings

12. Deck Flashings: It appears that the deck ledgers are properly attached to the house, with flashings both above and behind the ledgers (Photo 17). Some of the flashings have been damaged over time, and some appear to have been bent during construction. Still, the deck ledger flashings were well done and appear to be functioning properly.

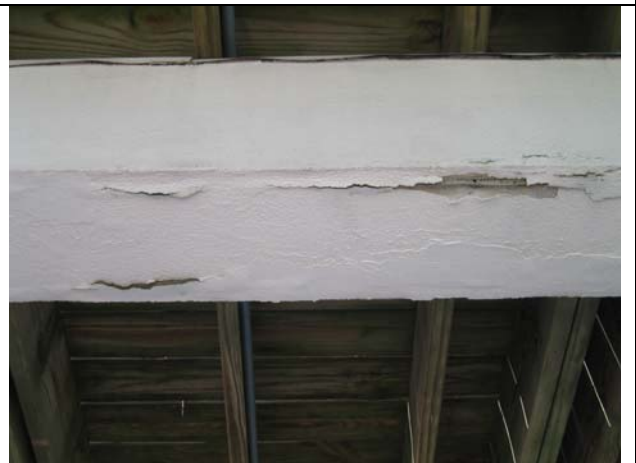
Photo 18. Moisture Damage to EIFS

There is severe moisture damage to the EIFS wrapping the deck beams in back (Photo 18). The water is entering through the top flashings on the beams, because these flashings were improperly installed as 2-piece flashings with cutouts for the beams. It appears that the flashings were an afterthought, and they are not functioning to shed water from the beams.

In back, it is not clear whether there is damage to the deck supporting beams and columns or not. Our moisture testing indicated that they are currently wet, and the physical condition of the EIFS on the beams clearly shows long-term leakage and moisture entrapment. However, if these beams and columns were made with preservative-treated wood, they may have sustained no structural damage from the constant moisture. In fact, if they had been this wet for 17 years, we would expect serious structural damage at this point, and the wood still seems solid. Regardless, it will be necessary to remove the EIFS for inspection if not simply to repair the EIFS. At that time, the beams can be directly examined for damage and repaired as necessary.

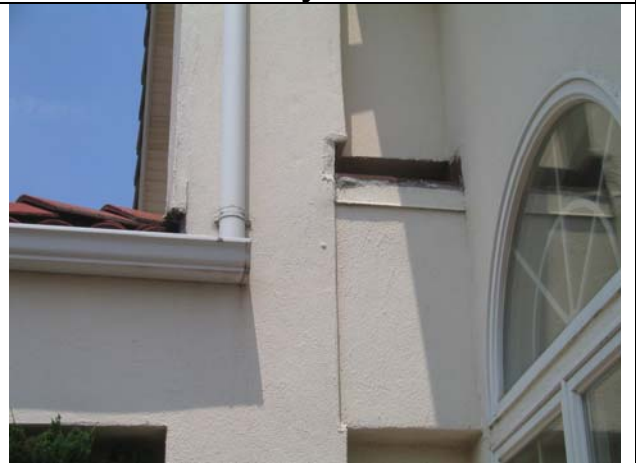
Photo 22. Difficult Scupper and Roof Detailing

In fact, the roof details are generally well done. There are some very difficult architectural details in front, where different roof slopes intersect with balcony railings, scuppers, gutters and other details. It seems that the flashings were well planed and installed, and we found little moisture intrusion in these locations.

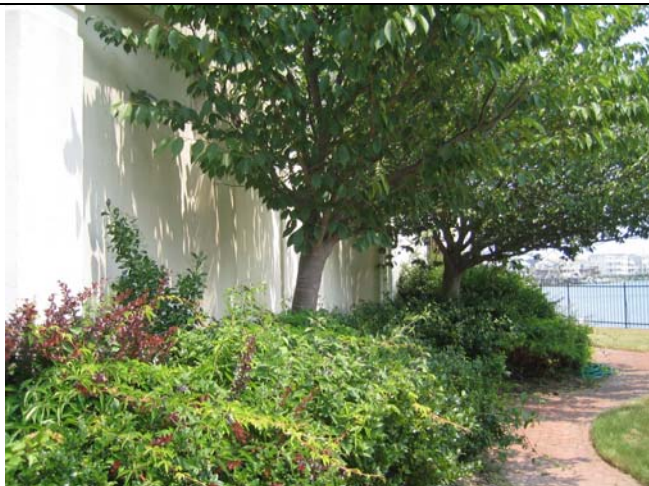
Photo 23. Vegetation Against House

The grading around the house is generally flat, and in some areas, the soil is graded towards the house. This concentrates moisture against the EIFS and foundations, and it can increase insect activity and water damage to the finishes at grade. Heavy shrubbery and trees growing against the house (Photo 23) decrease light and ventilation, and reduce drying potentials.
