EIFS Moisture Intrusion Inspection Report

Prepared for: John Homebuyer
Property Location: 125 Waterfront Way.
The Shore, NJ 00000
Date: June 2005

Peter G. Engle, PE

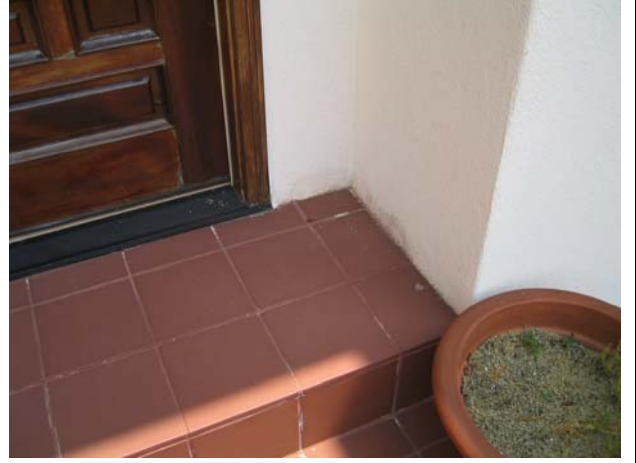
The EIFS has been installed below grade all around the house, and well below the front steps, which appear to have been placed against the EIFS (Photo 14, 15).

Photo 14. EIFS at Door and Stoop
